Technical Report C-13

Methodology And Effectiveness Of Drainage Systems For
Airfield Pavements

November 1974

Harry R. Cedergren

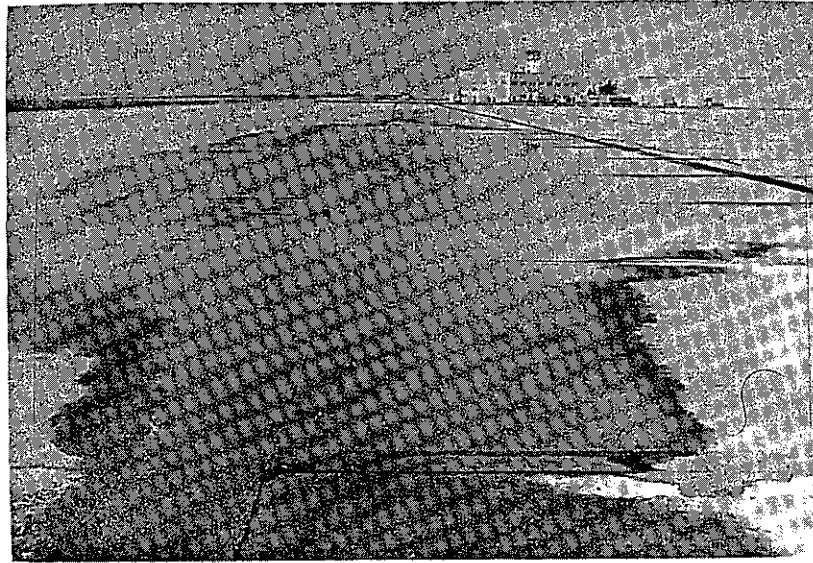
Figure B-3. Large "birdbath" in a taxiway leading to an Aircraft Parking Apron; large, wide areas such as this are often very difficult to drain because of limited initial cross slopes.

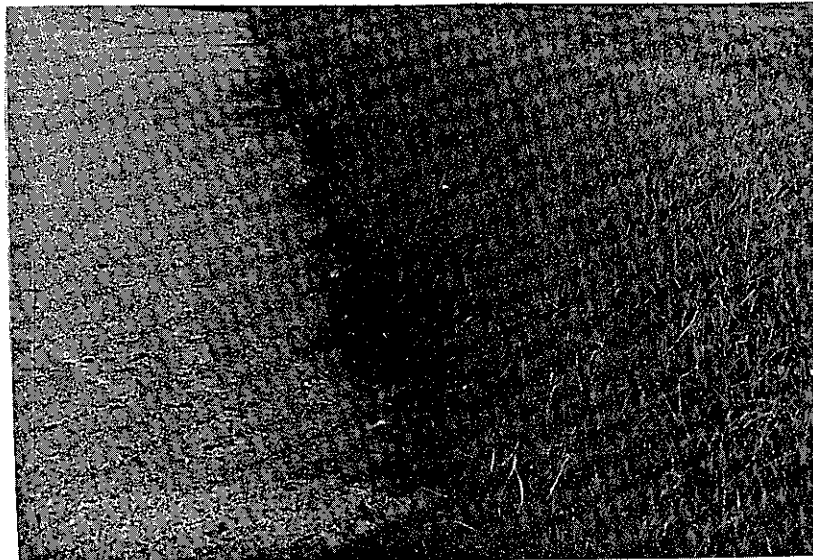
Figure B-4. Low view along edge of a Parking Apron showing high grass and sod which interfere with free drainage of paved area.

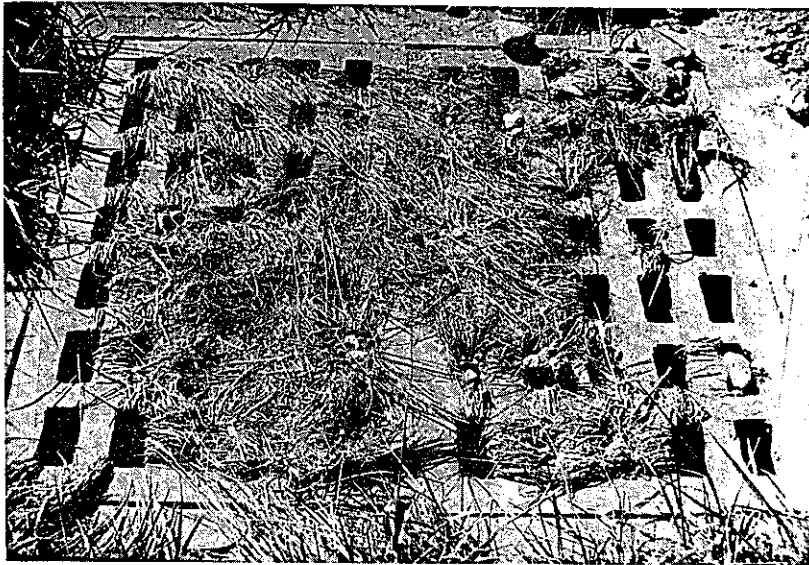
Figure B-5. Grated inlet in grassed area near a taxiway; grass and some gravel may be seen on inlet.

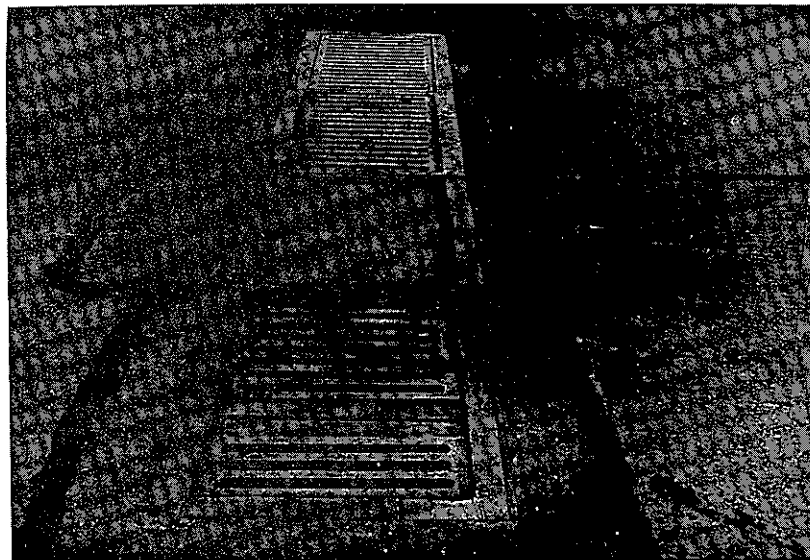
Figure B-8. Large grated inlet in an Operational Apron; has large capacity for water removal; base drainage may be slow here in this low area.

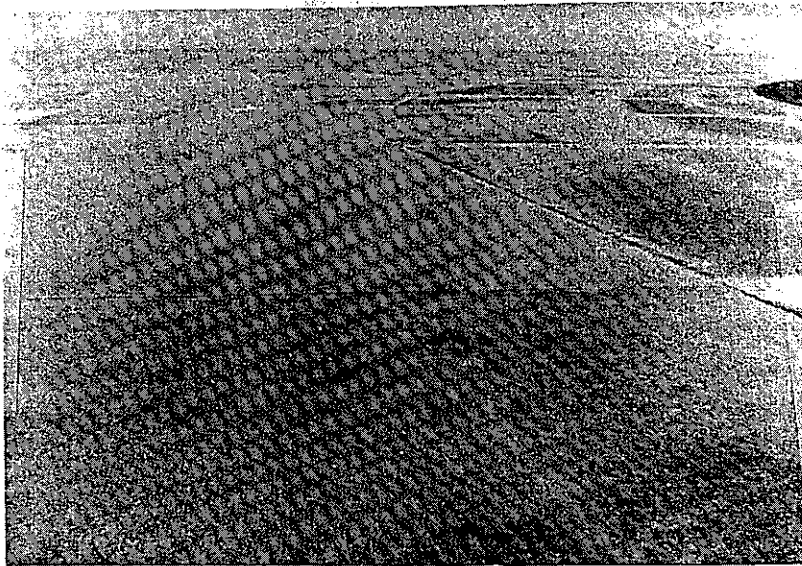
Figure B-9. Poorly drained area with much water still on pavement several hours after a rain.

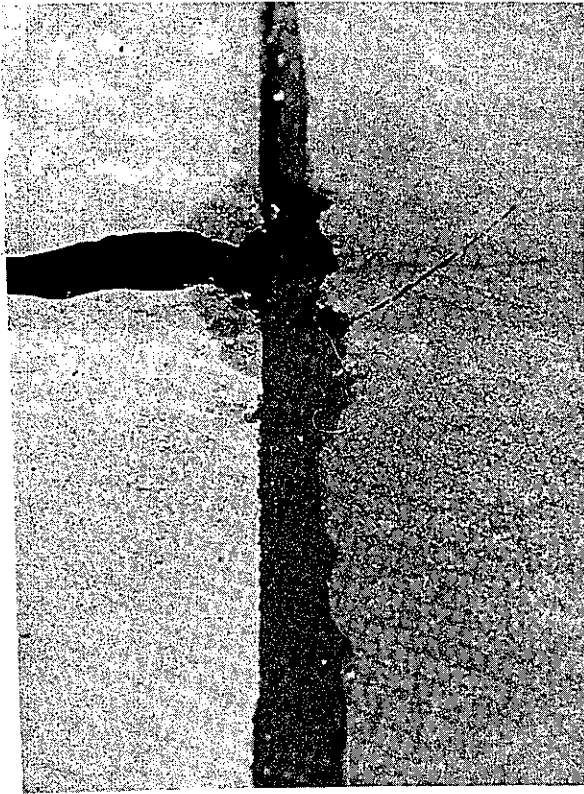
Figure B-15. Typical open joint in a 16-in. thick PCC pavement with preformed joint sealer and poured filler.

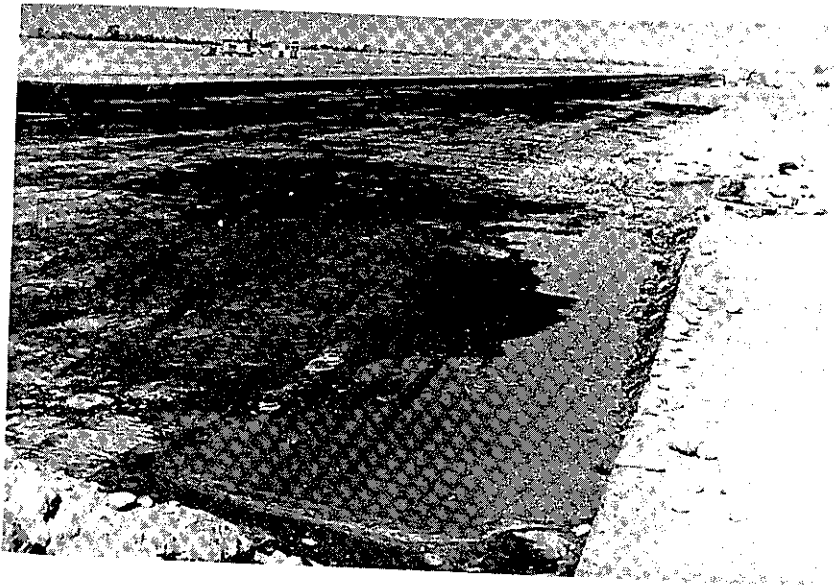
Figure B-29. Taxiway; dug out portion showing water is still standing on base in trench several days after light rain.

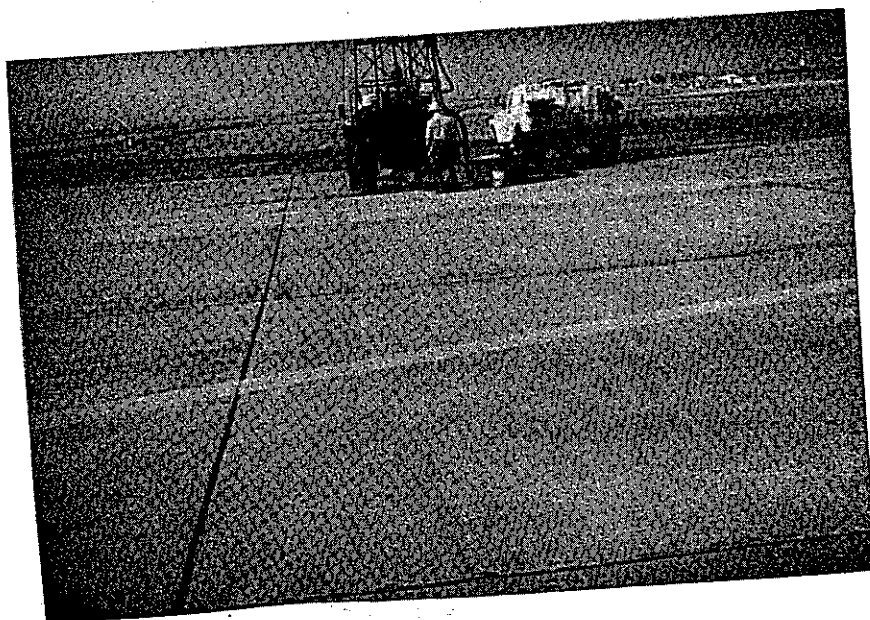
Figure C-2. Drill rig at Well 4; this area has poor surface drainage and very slow subsurface drainage; free water stays in structural section a long time after it stops raining.

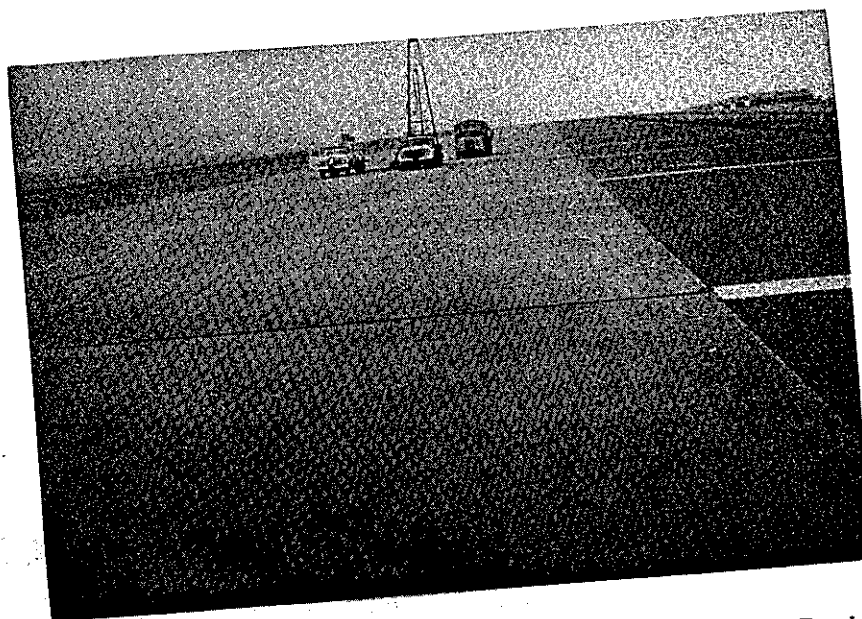
Figure C-3. Drill rig at Well 6; low swale in East Taxiway; water stays in structural section a long time after it stops raining.

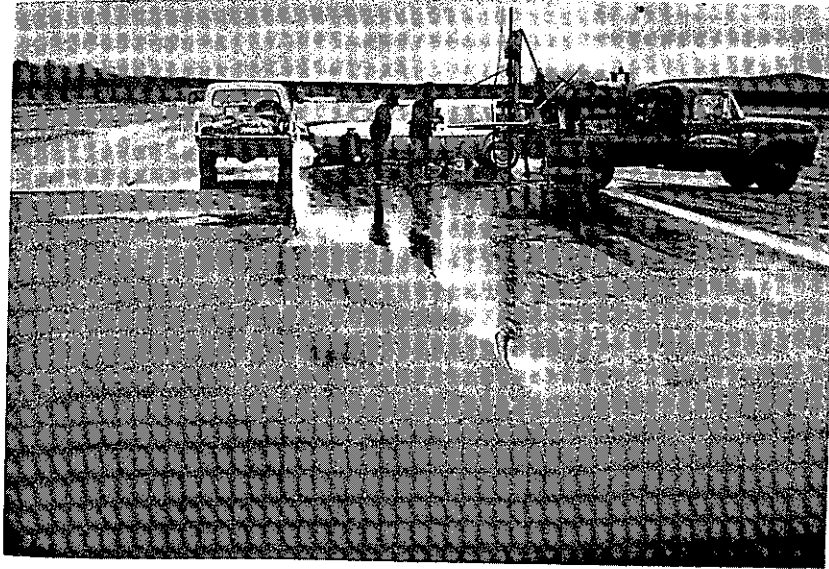
Figure D-2. Photo of drilling equipment at Well 1; near centerline of Taxiway G at Calibration Hardstand; stopped raining about 2 hours ago; some water entrapment on surface of pavement.

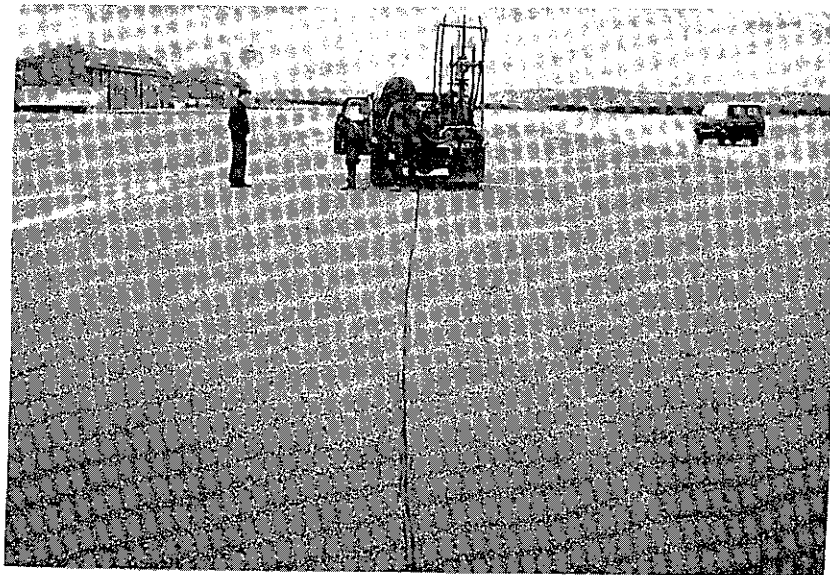
Figure D-3. Photo of drilling equipment at Well 4; Taxiway G at Dock 32; base course under 6-in. thick AC pavement is very open-graded trap rock.

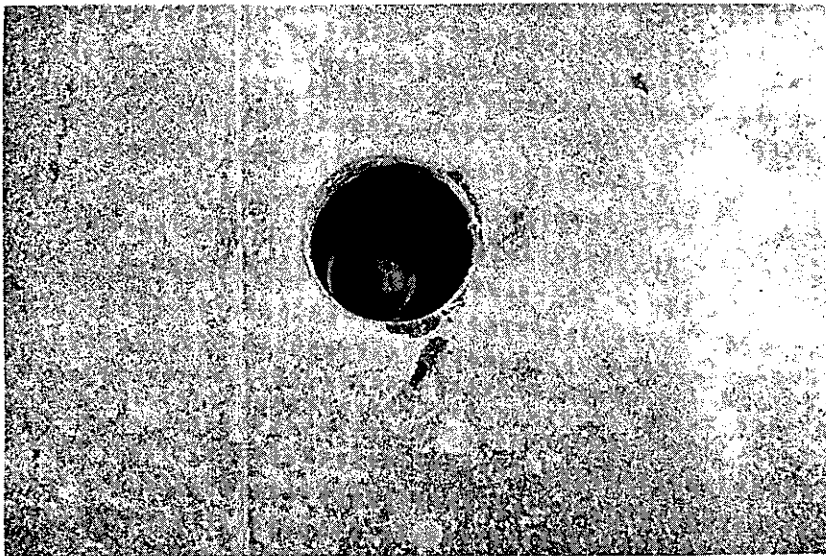
Figure D-5. Looking down into hole 2 after drilling to 18-in. depth; water stood 12 inches below top of pavement--from water used in drilling hole; light is being reflected off water in hole.

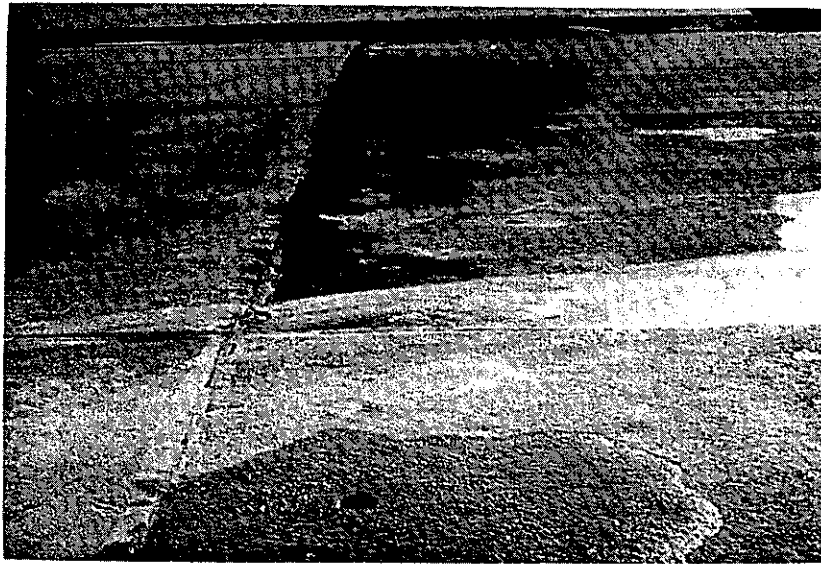
Figure D-8. Photo at Wells 6-8, looking SW; the stains are from drilling; Well 6 in foreground is in 20-in. PCC; Wells 7 and 8 are in 7-in. AC on coarse trap rock.

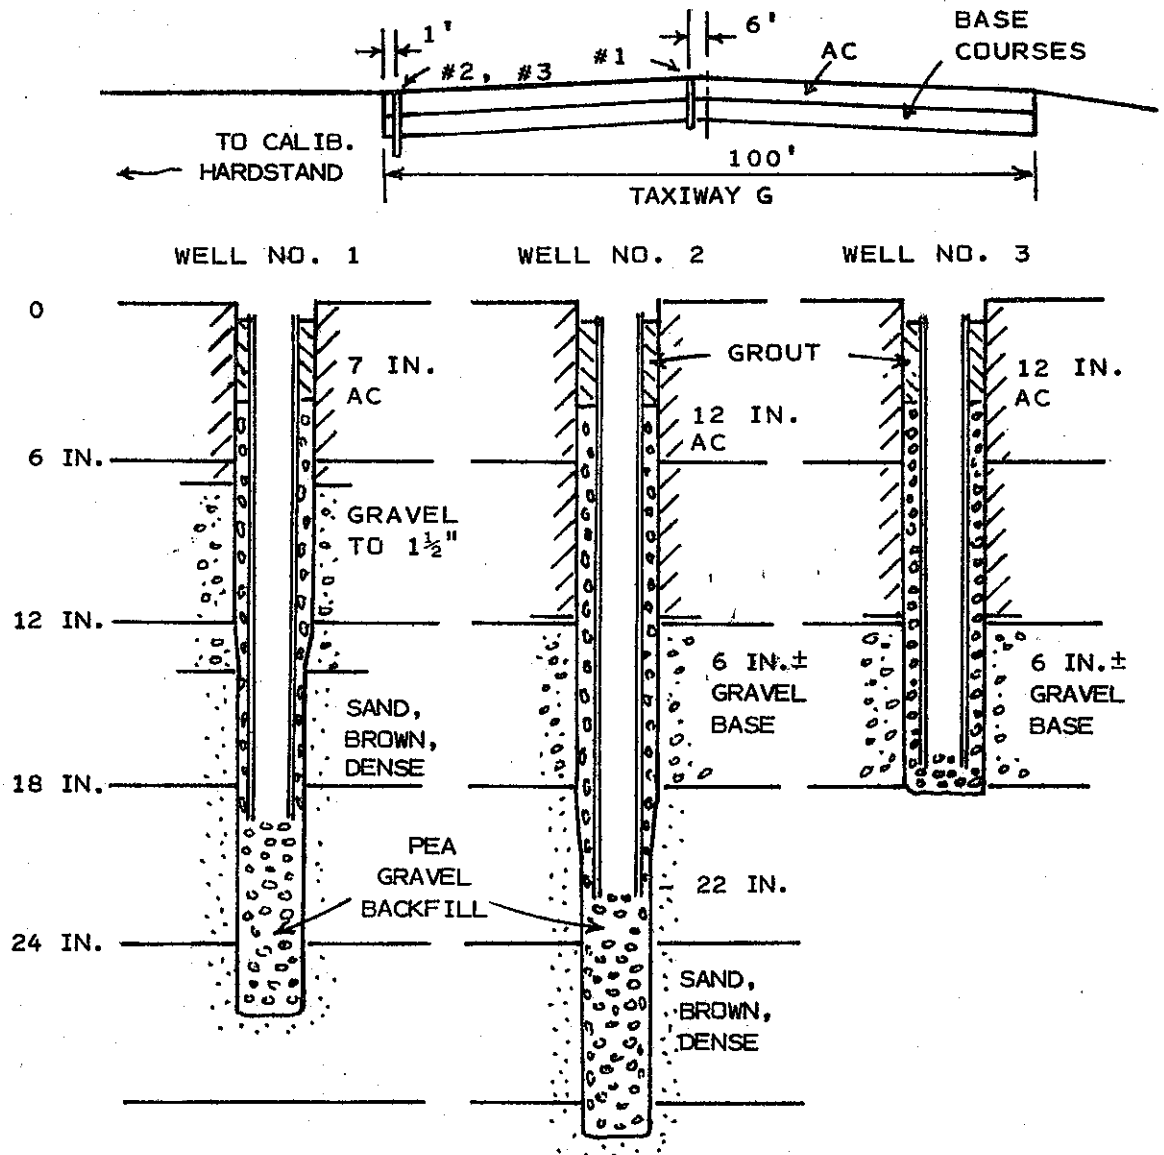
TAXIWAY G AT CALIBRATION HARDSTAND

Figure D-10. Logs of wells 1 to 3.

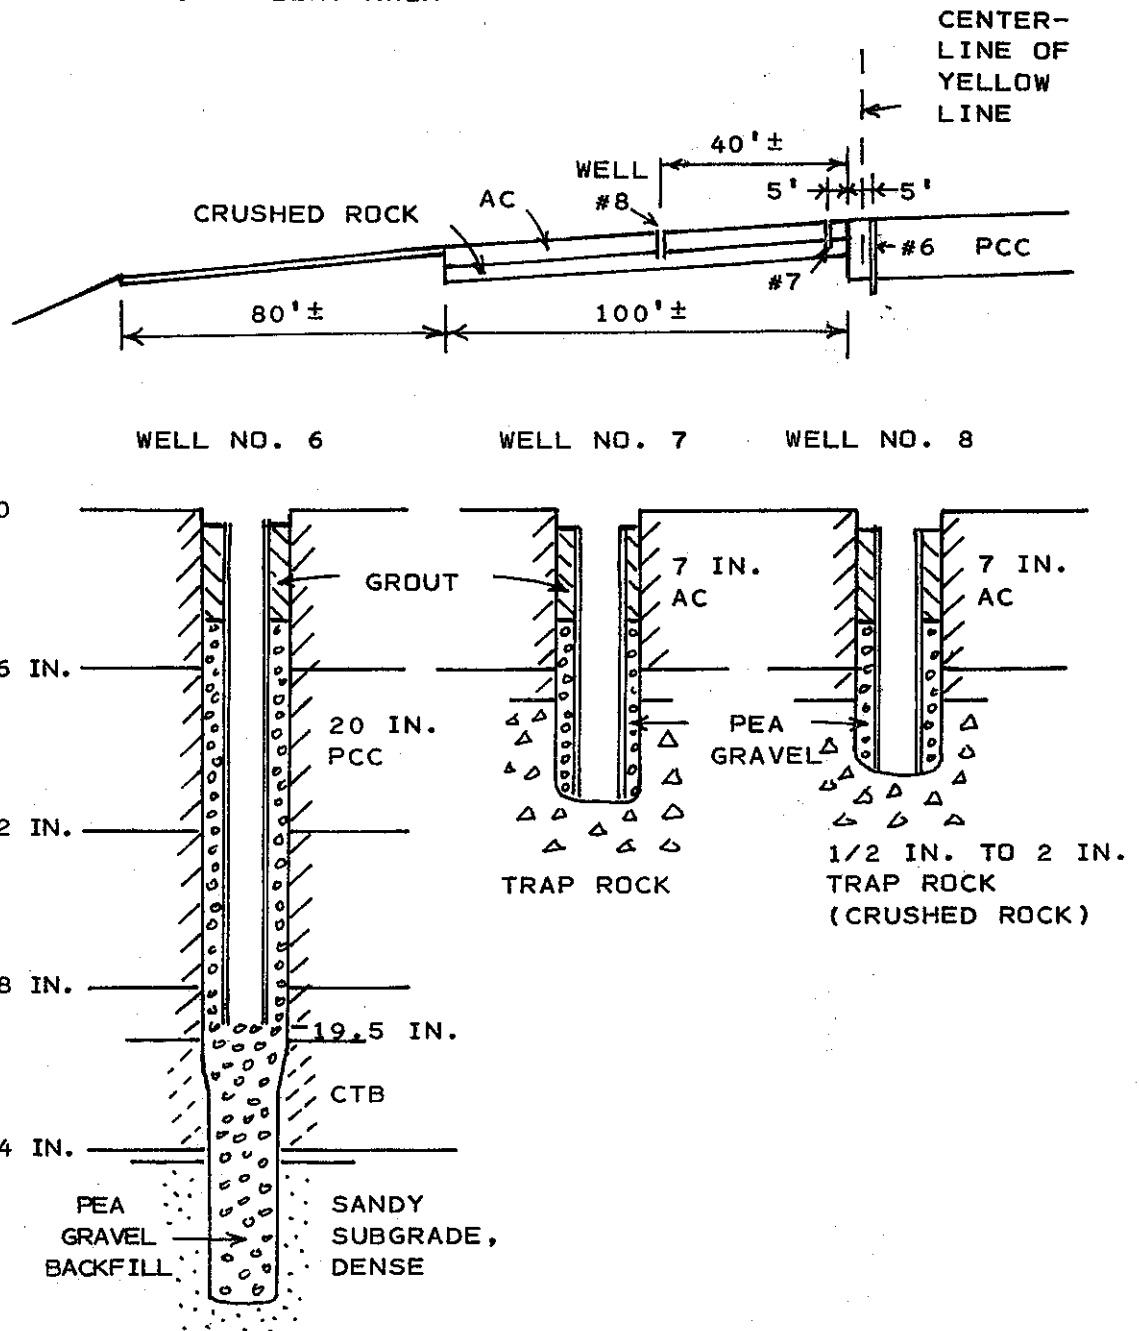
S.W. WARM-UP APRON AND TAXIWAY,
NEAR SAC ALERT AREA

Figure D-12. Logs of wells 6 to 8.

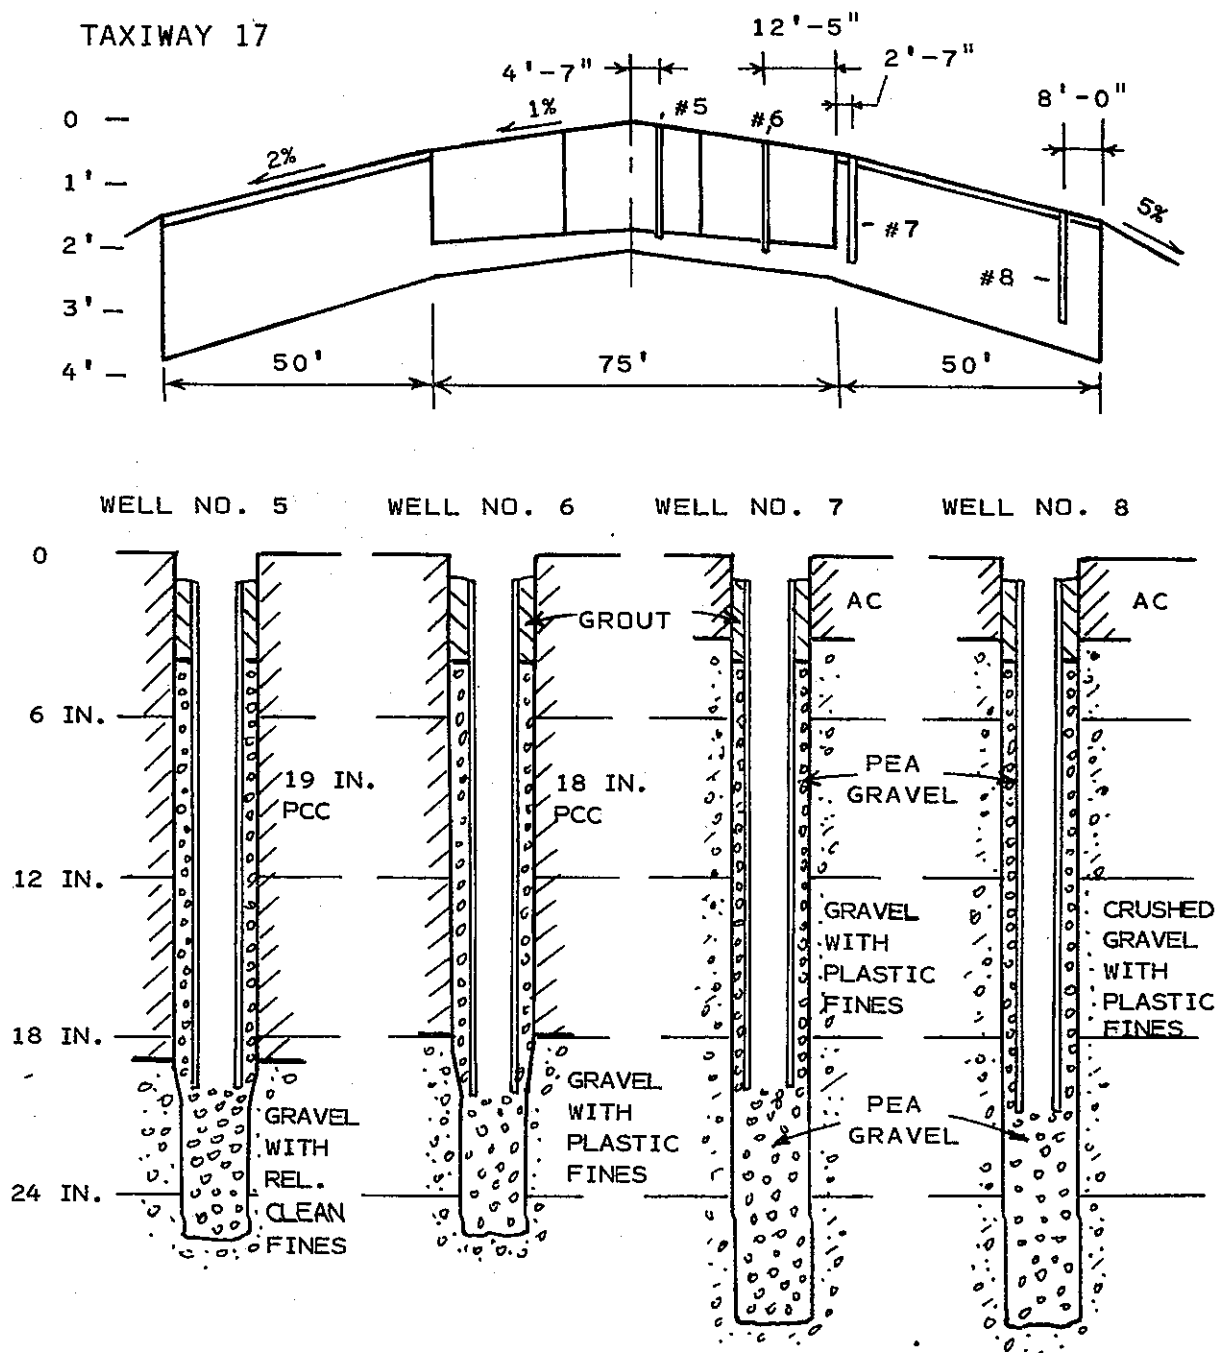
Taxiway 14. At this location, Wells 1 and 2 were cored into the PCC pavement and 3 and 4 were drilled into the AC shoulder (see Fig. E-3). The PCC pavement shows no physical distress, although the shoulders in this area are badly cracked. As may be seen in Figures E-5 and E-6, the water level builds up to the top of the pavement during showers, but drops rapidly to a foot or so below the surface after it stops raining. Lower parts of the structural section remain filled with free water a long time after each rain. As may be seen in Fig. E-10, the section is essentially in a "bath-tub" for appreciable amounts of time.

Figure E-3. Logs of wells 5 to 8.

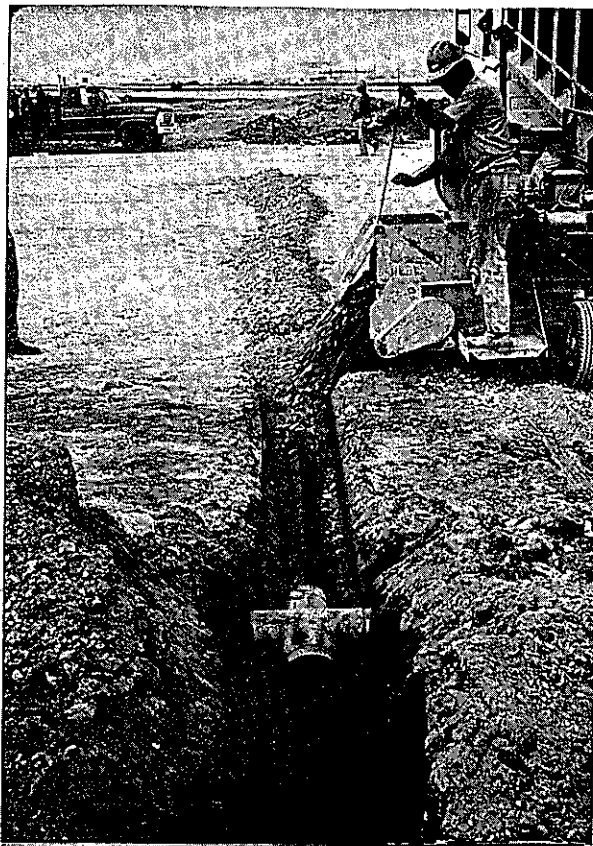
Figure F-2.
Placing blend of
ballast rock and
fines around and
over pipe in an
underdrain (1972
construction); is
similar to mate-
rial used in part
of 1969 work.

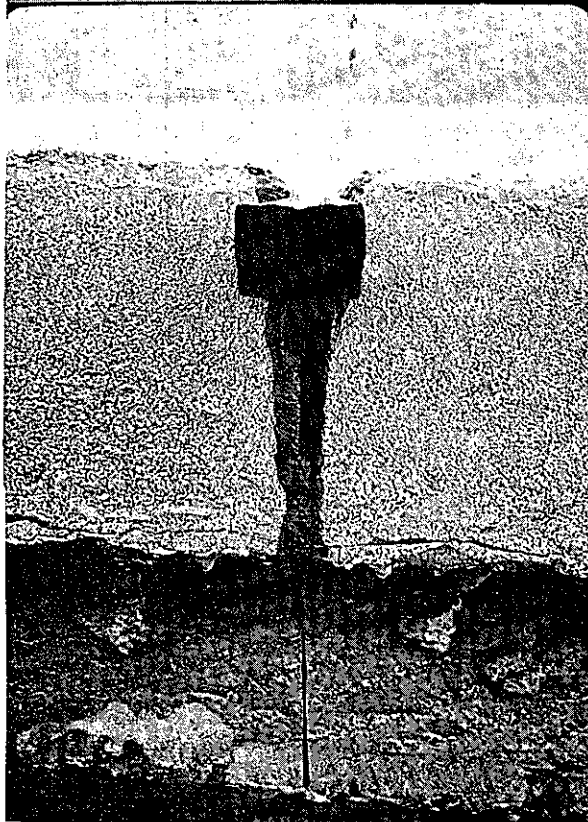
Figure F-3. Ex-
panded end of
neoprene seal
squeezed into sawed
joint in 16-in.
PCC pavement of
new South Runway
(1972 construc-
tion); is approx-
imate equivalent
of seals used in
1969 work.

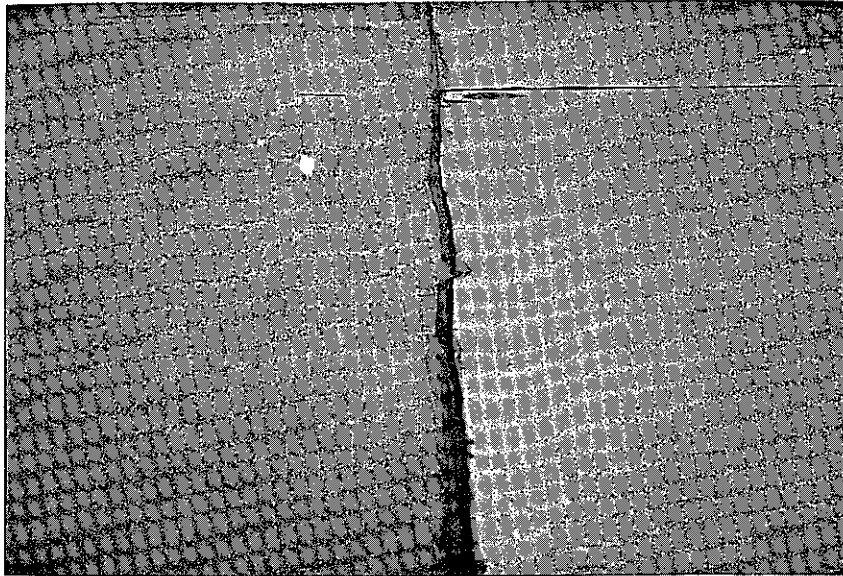
Figure F-4. Opened construction joint in PCC pavement on Taxiway B at Exit G; 1969 construction.

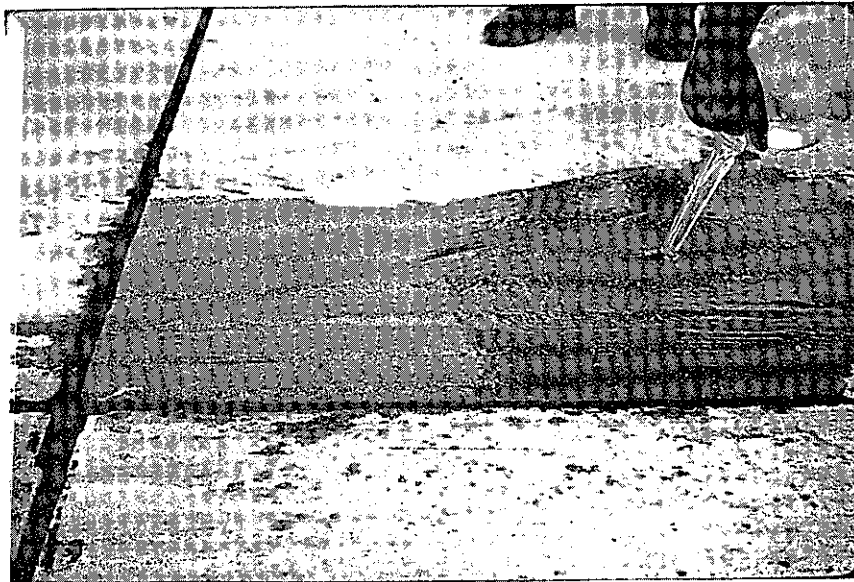
Figure F-8. Shows water entering open joint in 16-in. PCC pavement constructed in 1969; gallon jug of water disappeared into joints shown in photo in about 1 minute.

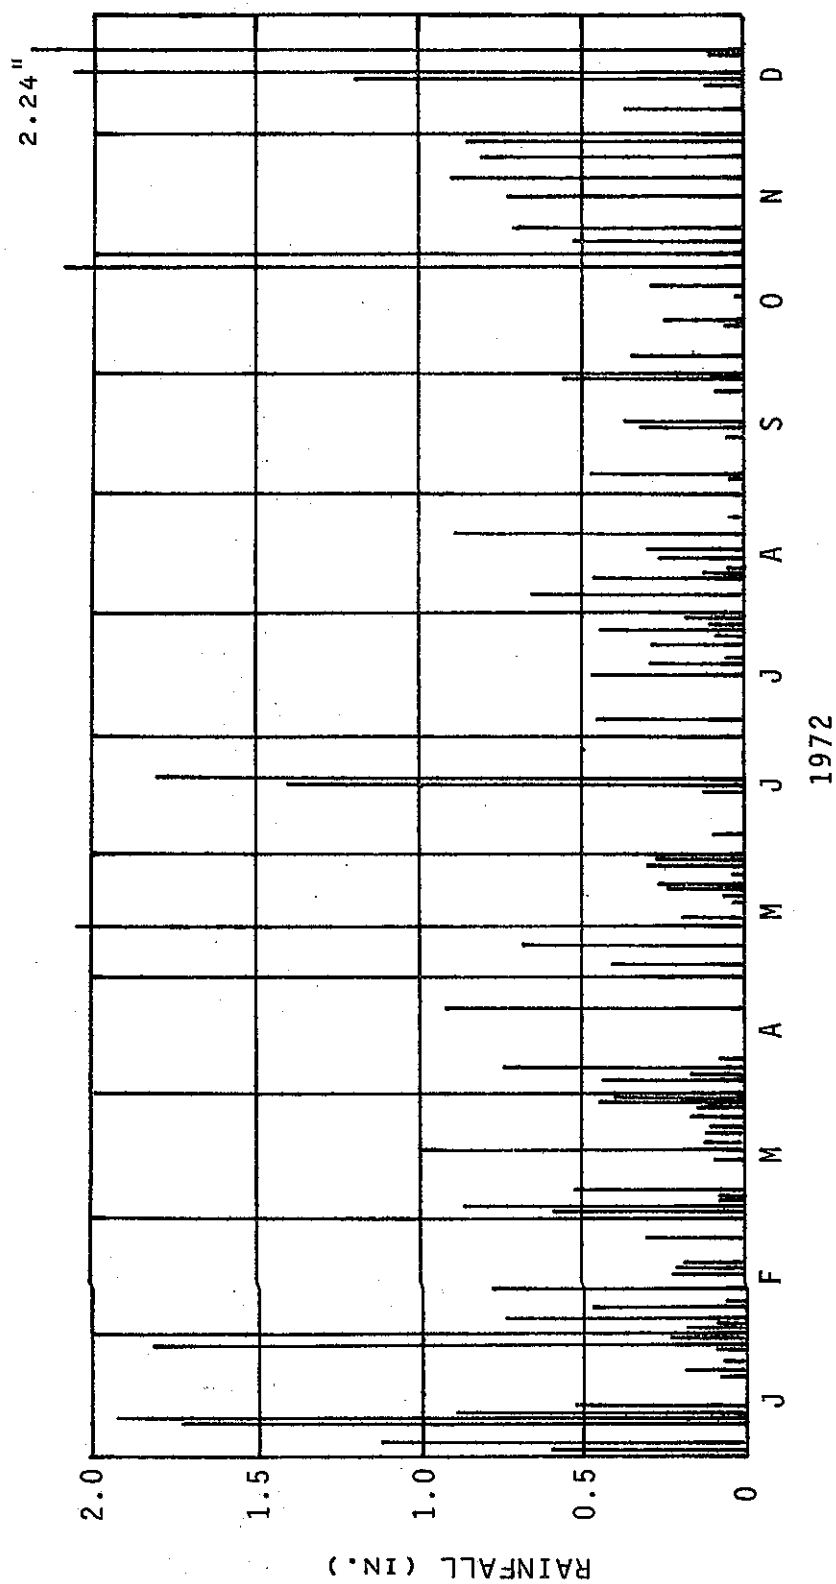
According to U. S. Weather Department records, this airport can expect to have 50 to 60 significant showers or rainstorms each year, as may be noted by examining Fig. F-12, which gives the rainfall events near the airport in 1972. Without rapid drainage, pavements in this kind of climate may contain free water essentially 100% of the time each year. Runway 9L-27R and taxiway pavements with their subsurface drainage system may be exposed to excess water during periods of heavy rainfall, and for short periods of time after each significant rainfall event. The total annual exposure of the structural sections of these pavements to excess water is considered unlikely to exceed about 40 days total time each year for the majority of the pavements, with localized areas exposed somewhat greater amounts of time which at present can only be surmised from outflow readings.

Figure F-12. Rainfall events near Airport G in 1972.
